## Prevention of Fracture in Ship Structure

Committee on Marine Structures Marine Board National Research Council 19970521 186

SR-1363

## SYMPOSIUM AND WORKSHOP ON THE PREVENTION OF FRACTURE IN SHIP STRUCTURE

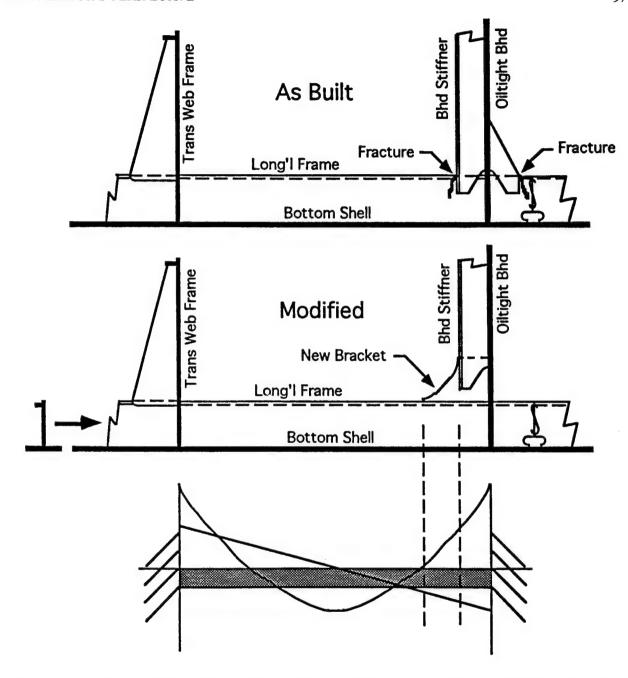
Figure 7 shows the connection between a vertical stiffener on an oiltight bulkhead and a bottom longitudinal (ABS Grade A steel) as built in Class C, the fracture location, and the repair/modification applied. An odd feature about this joint is the placing of the bracket on the opposite side of the bulkhead from the bulkhead stiffener in the original design. A bottom longitudinal segment between transverse supports approximates a built-in beam with local bending stress from the uniform hydrostatic loading and a primary stress field resulting from the macrobending of the hull girder. The longitudinals are asymmetrical built-up profiles; thus, the state of stress in this structure is further complicated by the torsion that results because, in this case, the hydrostatic shear load does not pass through the shear center of the longitudinal. Fatigue damage occurs because the primary and local bending stresses and the torsional shear stress oscillate about a mean value due to the passage of waves. In the original design, the bracket toe and the outer edge of the bulkhead stiffener attached to the longitudinal, where the secondary moment and shear in the longitudinal are about 50 percent of the maximum values or greater. Initially fractures occurred in the longitudinal where the bulkhead stiffener is lapped onto it or at the bottom of the bracket where it ends against the longitudinal. The bracket toe in the original design is above a drainage cutout in the bottom of the longitudinal. Co-locating these two features was another source of trouble that led to through-fractures of the longitudinals in some cases. When fractures occurred where the bulkhead stiffener lapped onto the longitudinal, an unanalyzed field repair added a bracket on the same side of the bulkhead as the bulkhead stiffener at some locations. The resulting joint was much stiffer than the original, and new fractures soon occurred at the top of the new bracket. Subsequently both brackets were removed, and a single bracket was

FIGURE 7 Class C bottom longitudinal frame intersection with transverse oiltight bulkhead.

Figure 7 also shows that the web of the longitudinal extends beyond the flange, which is welded onto the side of the web. In this case, the most highly stressed fiber of the beam is the

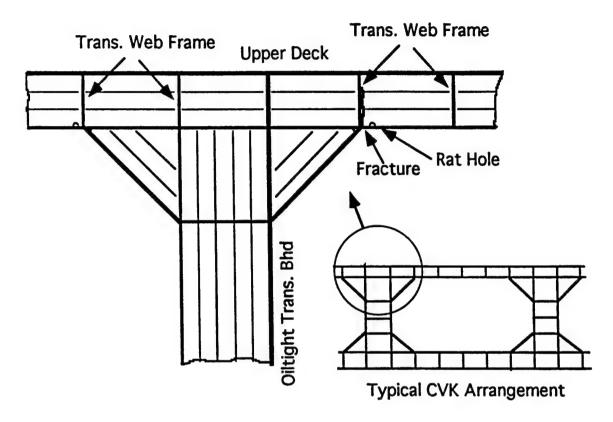
The fractures originated at or near the aft end intersection of the CVK underdeck girder and the transverse web frame girder at the top of the knee bracket and were detected when the ships were about 5 years old. The initial discovery occurred after the crew reported banging sounds coming from a center cargo tank at sea. Figure 10 shows the geometry of the CVK and knee bracket as originally built. The design is characterized by massive and rigid brackets, creating fixed-end connections restraining the ends of the vertical member. The brackets are kept from rotating under load by their attachment to the grillage formed by the horizontal members of the CVK and the transverse web frame girders at the deck and bottom. The moments are resisted by vertical reactions at the fore and aft toes of the brackets. The bracket toes coincide

FIGURE 10 Class B CVK at intersection of upper deck and transverse oiltight bulkhead, as built.

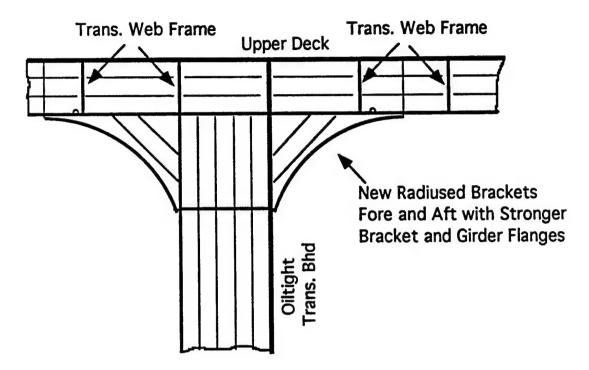
FIGURE 11 Class B modified CVK at intersection of upper deck and transverse oiltight bulkhead.

Figure 11 shows the detail of Figure 10, as modified to prevent reoccurrence of fracturing. The design strategy aimed at reducing the bracket-toe stress concentration with radiused transitions between the knee brackets and the CVK horizontal girder and removing free-plate

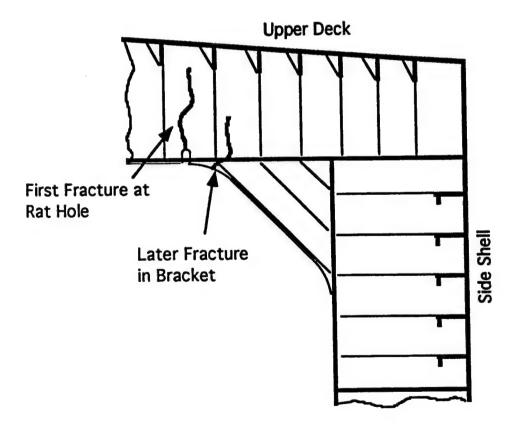
The use of high-strength steel may have contributed to the early failure of the CVK. This does not mean that the use of mild steel will prevent these kinds of fractures, regardless of the design process. Figure 12, the next example, shows a similar fracture that occurs in the mild-steel transverse web frames of this same class, apparently caused by local details that interfered with the load path through a highly stressed area. Figure 12 shows a near-full-depth fracture that occurred at a few locations at the outboard end of the underdeck girder of the transverse web frames (ABS Grade A steel) in the wing tanks of Class B. Figure 12 shows the first of a series of fractures in this general area of the web frames in the mid-length of the ships, which began after about 3 years of service. At the time, this fracture was not explained. The importance of fatigue as a failure mechanism was not appreciated, and FEA identified maximum stresses insufficient to cause failure. The cause was erroneously assumed to be related to stresses locked in during the construction process. It is now understood that these were fatigue fractures that are

FIGURE 12 Class B transverse web frame at intersection of upper deck and side shell as built.

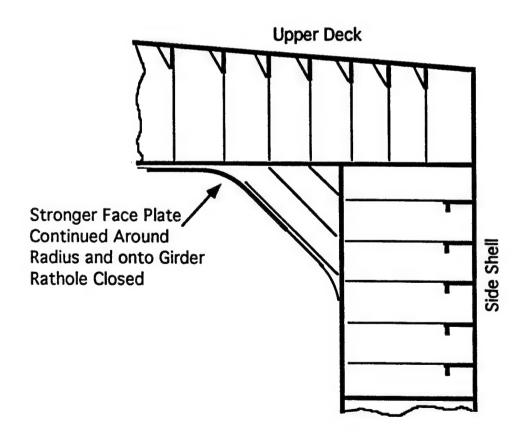
FIGURE 13 Class B modified transverse web frame at intersection of upper deck and side shell.

Functionally, the new design provides a path for load from the girder flange into the 45° bracket panel stiffener, where it can be dissipated into the bracket web. This new path replaces the original path, through the gap between the girder flange and the bracket panel stiffener, and eliminates the free-plate edges of the girder and bracket webs in the region of greatest stress. The new bracket flange is extended inboard under the girder web far enough to allow the girder flange

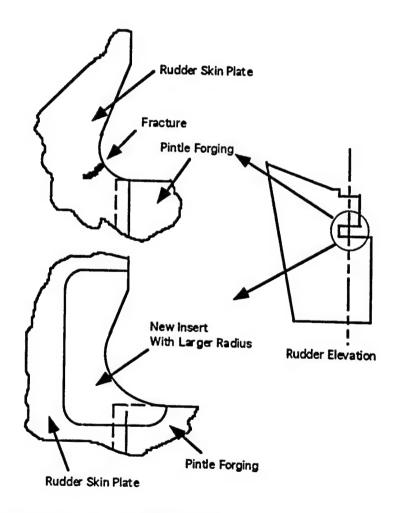
Significant fractures may also occur in tanker structure outside of the cargo block. Figure 14 shows a fracture that occurred in the throat of the cutout in the skin plate of the rudder at the pintle-pin casting in ships of Classes A, C, and D. About 10 years ago, a ship of Class C lost approximately the lower half of its rudder due to a fracture of this type. Following that incident, the rudders were modified by replacing the skin plate locally in the area of the

FIGURE 14 Rudder fracture and modification plan.

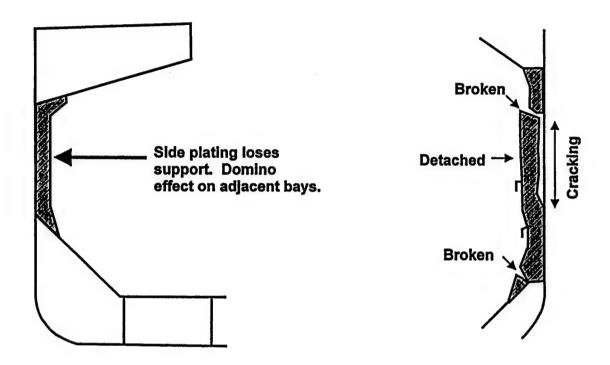
The structural wear due to routine vessel operations has recently been of interest. The effects of today's very high speeds of loading were essentially unanticipated in vessel design. In particular, grabs today may weigh as much as 30 tons, and their impact on comparatively light,

FIGURE 4 Bulk carrier side frame damage.

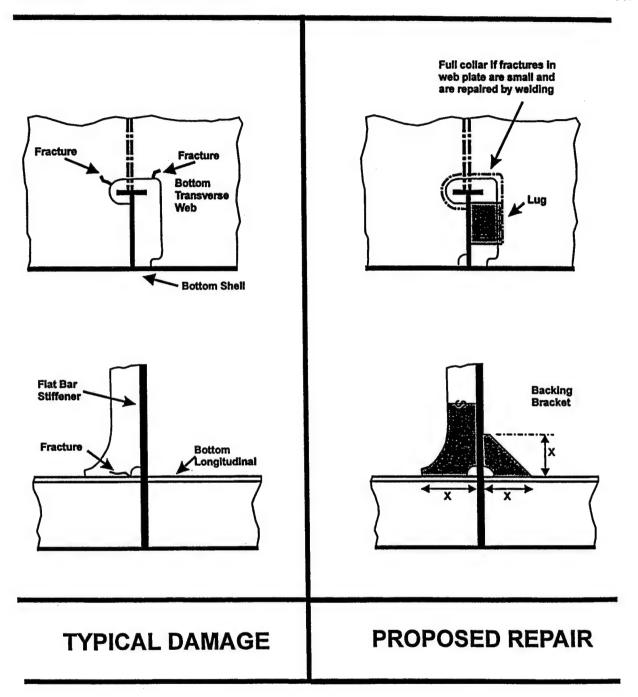
FIGURE 7 Tanker damage and repair example. Source: Tanker Structure Cooperative Forum (TSCF)

An example relating to the repair of cracking at the connection of longitudinals to transverse webs in tankers is shown in Figure 7. Finite element studies of similar situations have indicated an interesting fact—brackets backing the flat-bar stiffeners on web frames tend to help because they reduce their out-of-plane deformation (and related stresses). We might also state the obvious, that softening of the bracket toes helps. Repeated occurrences of cracking in the same area may indicate a need for structural strengthening or modifications. Options for such modifications include provision of soft toe brackets, providing backing brackets on the other side

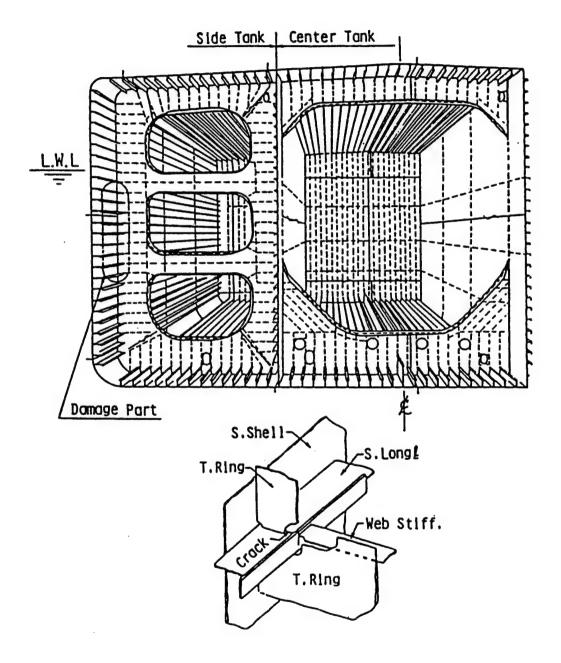
FIGURE 6 Example of fatigue crack of side longitudinals. Source: Watanabe et al., 1995.

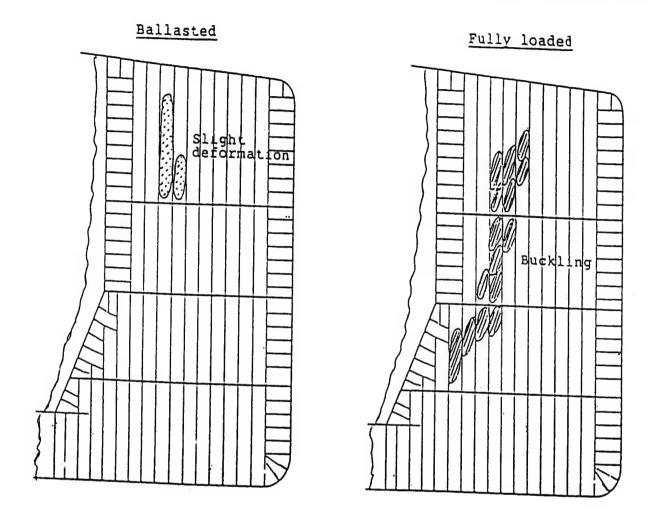
FIGURE 5 Buckling of transverse bulkhead plating in wing tank of an ore carrier.

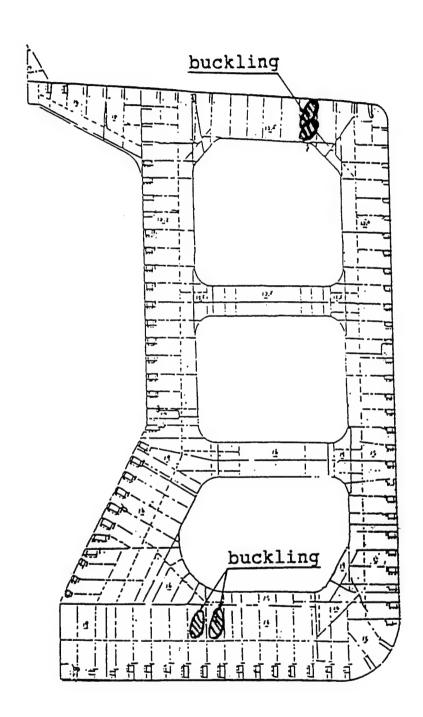
FIGURE 5a Buckling of transverse web plate.
